# Cape Meares - Coleman Creek Watershed

Wendy Burroughs  
Cape Meares Community  
Association  
November 13, 2021

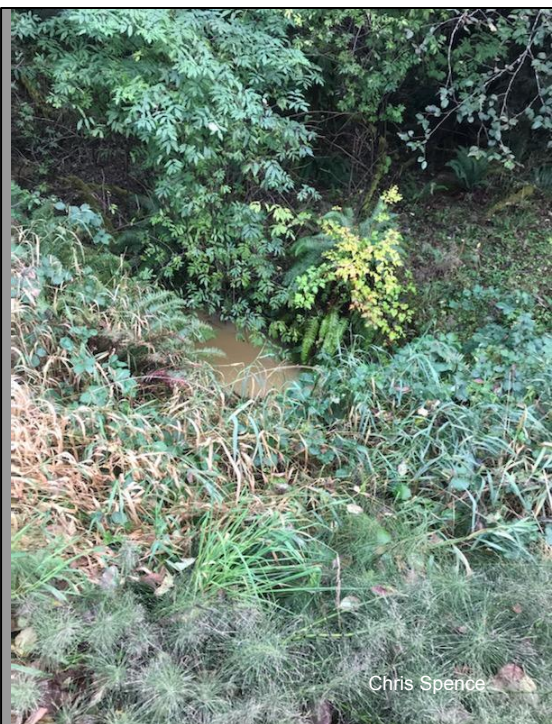
He notices muddy water flowing through the culvert under Bayocean road between 12th and 9th streets.

Devin Field notices that the usually clear stream is muddy brown with silt.

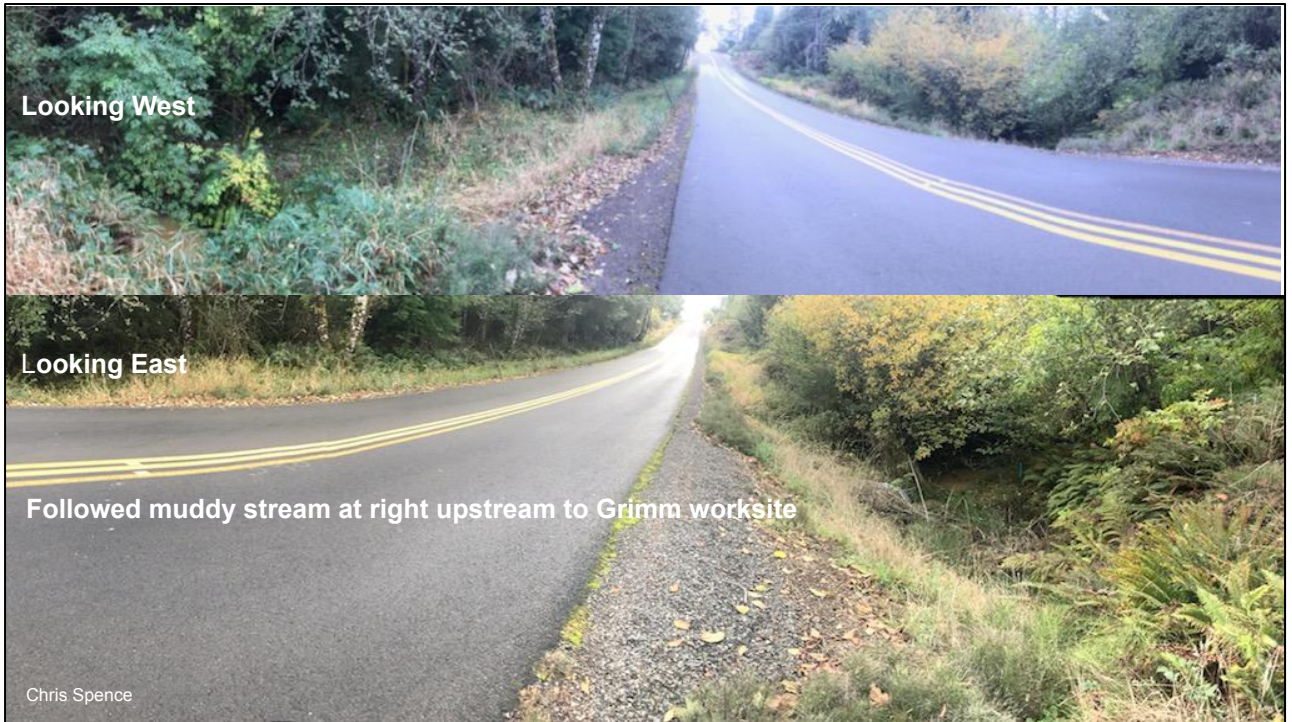
The stream crosses through a culvert under Bayocean Road between 9th and 12th and flows directly into Cape Meares Lake.

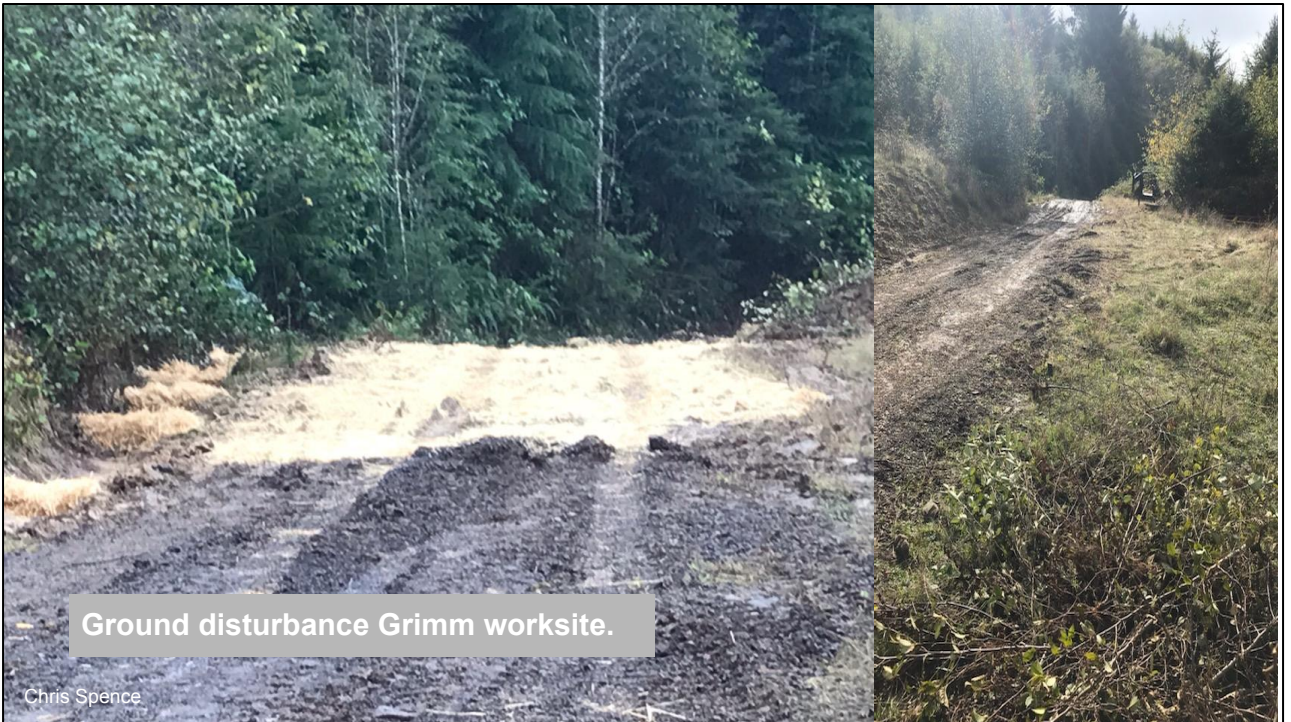
Following the sound of a machine, he discovered that John Grimm had begun a logging operation on his 120 +- acres West of the Loop Rd., East of 5<sup>th</sup>, South of the Cape Meares homesites, and bordering the property on the hill owned by CMCA. A muddy mess of a road was, being installed off the Loop Rd. just at the new blue water tower. No riparian protection was installed, hence the muddy stream.

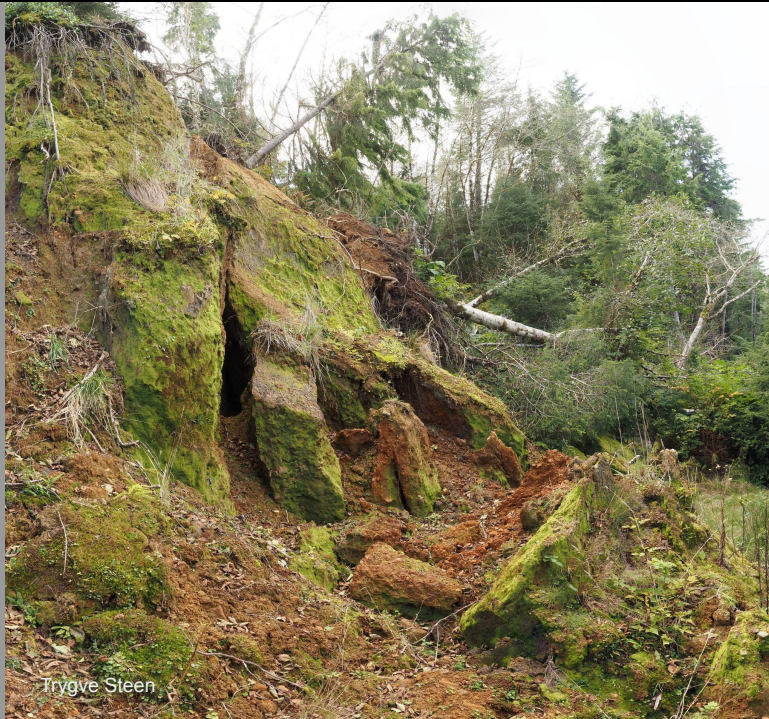
*"My group of photos shows more widespread ground instability than I have ever seen."*

*"This is clearly a very active slide area, there are even alders with leaves on them."*

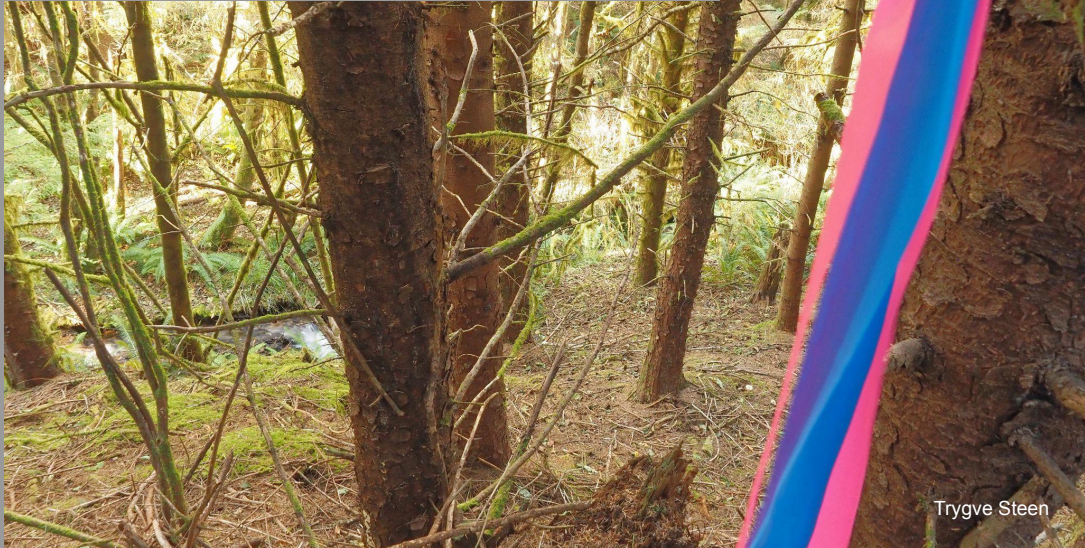
**The flagging is 50 feet slope distance from the stream. That is accurate for Oregon's Forest Practices Administrative Rules for a stream of that type. The issue is - It is a 45 degree angle to the stream which is a 100% slope. Therefore the flagging is 35 feet away from the stream horizontally.**

Washington State stream buffers are specified as horizontal distance. Therefore a 50 foot horizontal buffer becomes 71 feet slope distance, if Washing were to use such a small buffer..

With horizontal specifications for buffers, as the slope gets steeper, the distance increases.

This is an important contrast with Oregon, where steeper slopes let one log closer to the stream.

Also steep slopes increase the risk to the stream.

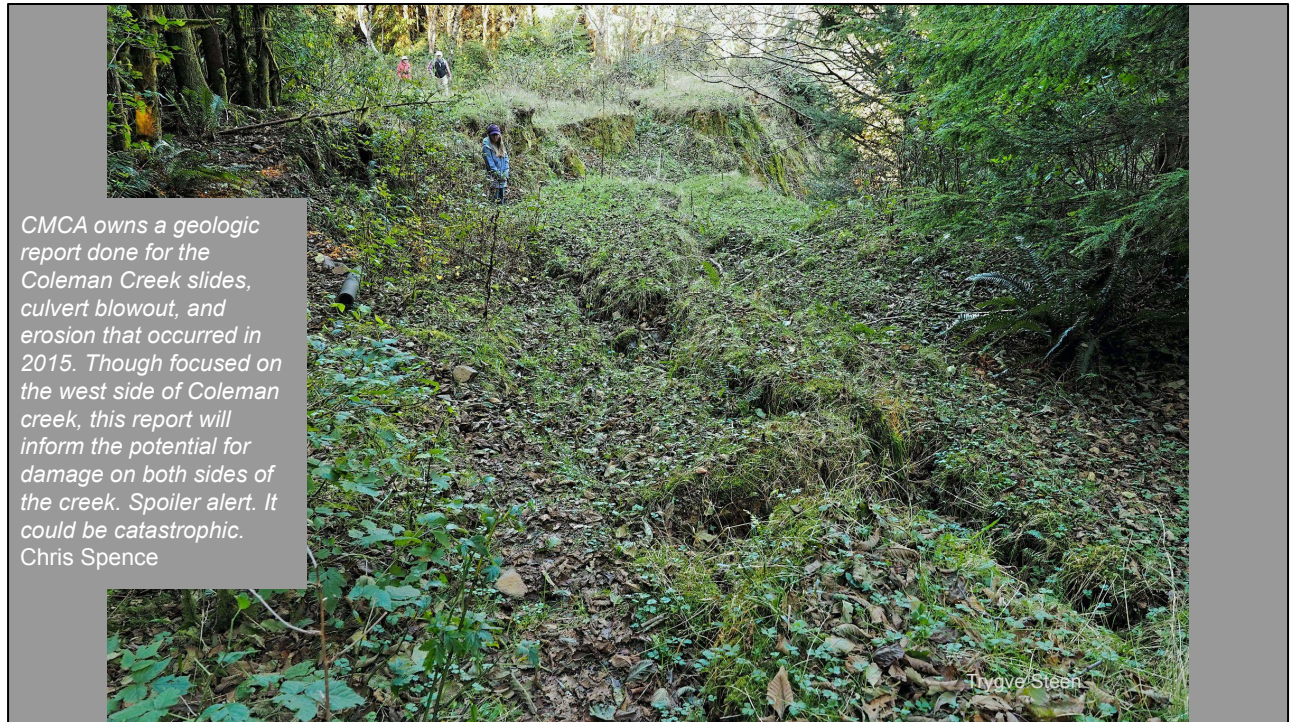
CMCA owns a geologic report done for the Coleman Creek slides, culvert blowout, and erosion that occurred in 2015. Though focused on the west side of Coleman creek, this report will inform the potential for damage on both sides of the creek. Spoiler alert. It could be catastrophic. Chris Spence

That is me standing at the edge of this crack. As you know water takes the path of least resistance. Water flowing into these huge cracks can have a destabilizing effect.

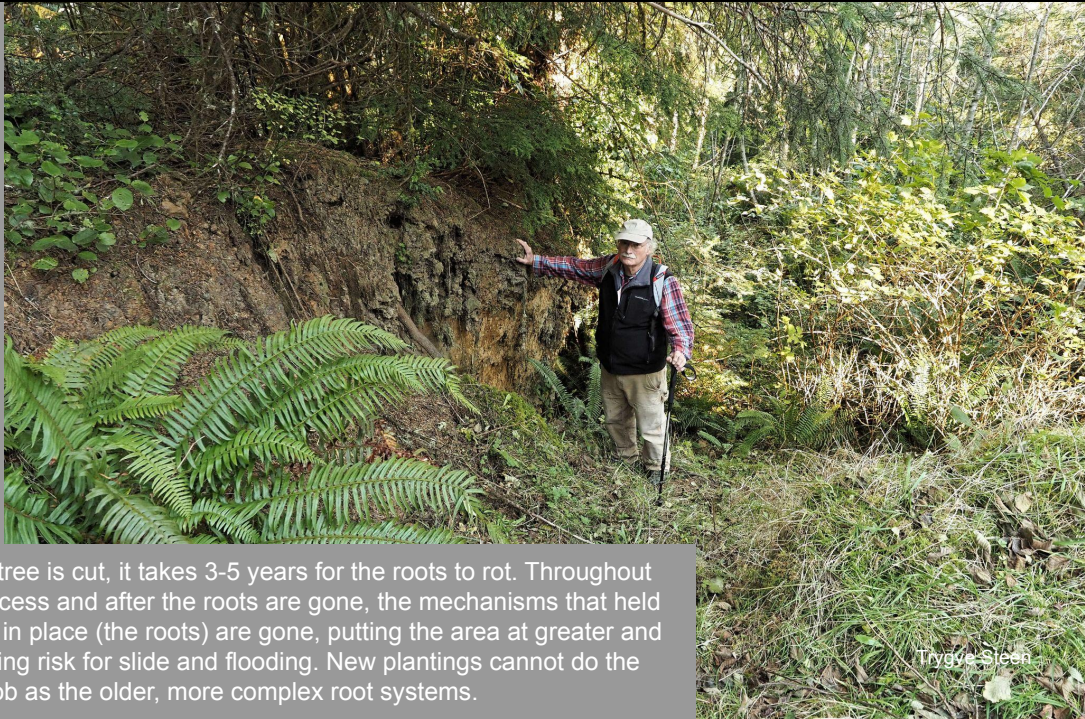
After a tree is cut, it takes 3-5 years for the roots to rot. Throughout this process and after the roots are gone, the mechanisms that held the soil in place (the roots) are gone, putting the area at greater and continuing risk for slide and flooding. New plantings cannot do the same job as the older, more complex root systems.

As these slides show there is an active slide area. This area has been logged several times and there have been road cuts made throughout that history. This photo shows erosion and landsliding at an old road cut. Tryg Steen suggested that these “gaps” in the mature tree root structure can contribute to land instability.

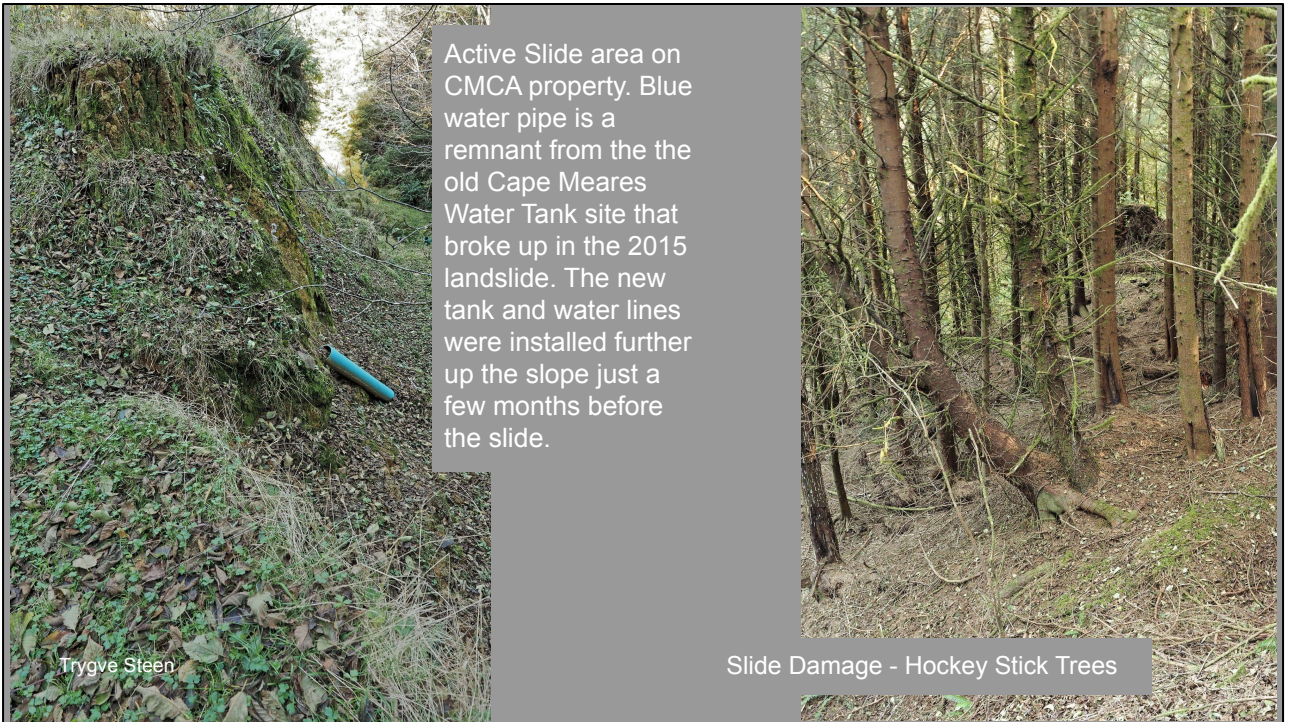
Slide Damage - Hockey Stick Trees

Active Slide area on CMCA property. Blue water pipe is a remnant from the the old Cape Meares Water Tank site that broke up in the 2015 landslide. The new tank and water lines were installed further up the slope just a few months before the slide.

Hockey stick trees are a sign that the land where the tree was rooted shifted and then the tree continued to grow vertically towards the sun. This is evidence of a slide that occurred some years ago.

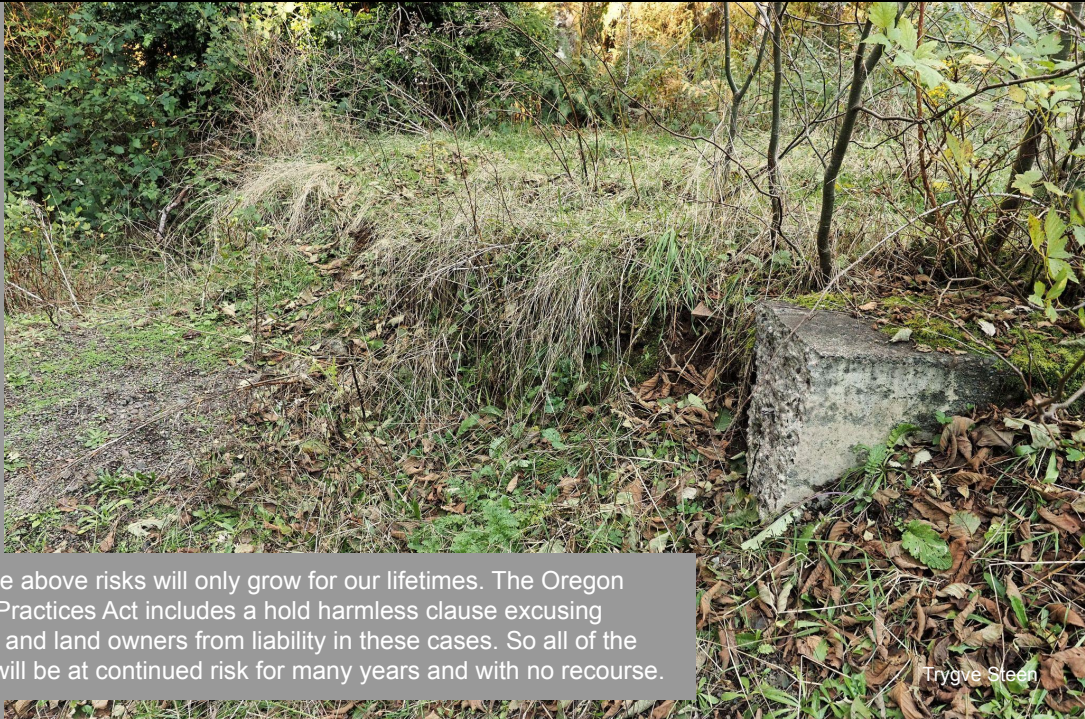
This photo shows a broken piece of the concrete foundation for the old Cape Meares water tank. What does this have to do with the proposed logging? On a good day, any day, today even, there is a risk of landslide that threatens life and property in the community of Cape Meares. All of the above risks will only grow for our lifetimes. The loss of 87.2 Acres of mature trees from the slide prone slopes elevates those risks. The Oregon Forest Practices Act includes a hold harmless clause excusing loggers and land owners from liability in these cases. So all of the above will be at continued risk for many years and with no recourse.
